MERIT AWARD

HARVARD GRADUATE SCHOOL OF DESIGN

WHERE THE ROAD ENDS A CENTER FOR REGENERATIVE BUILDING RUBBER PROTOTYPES FOR LAND & SEA

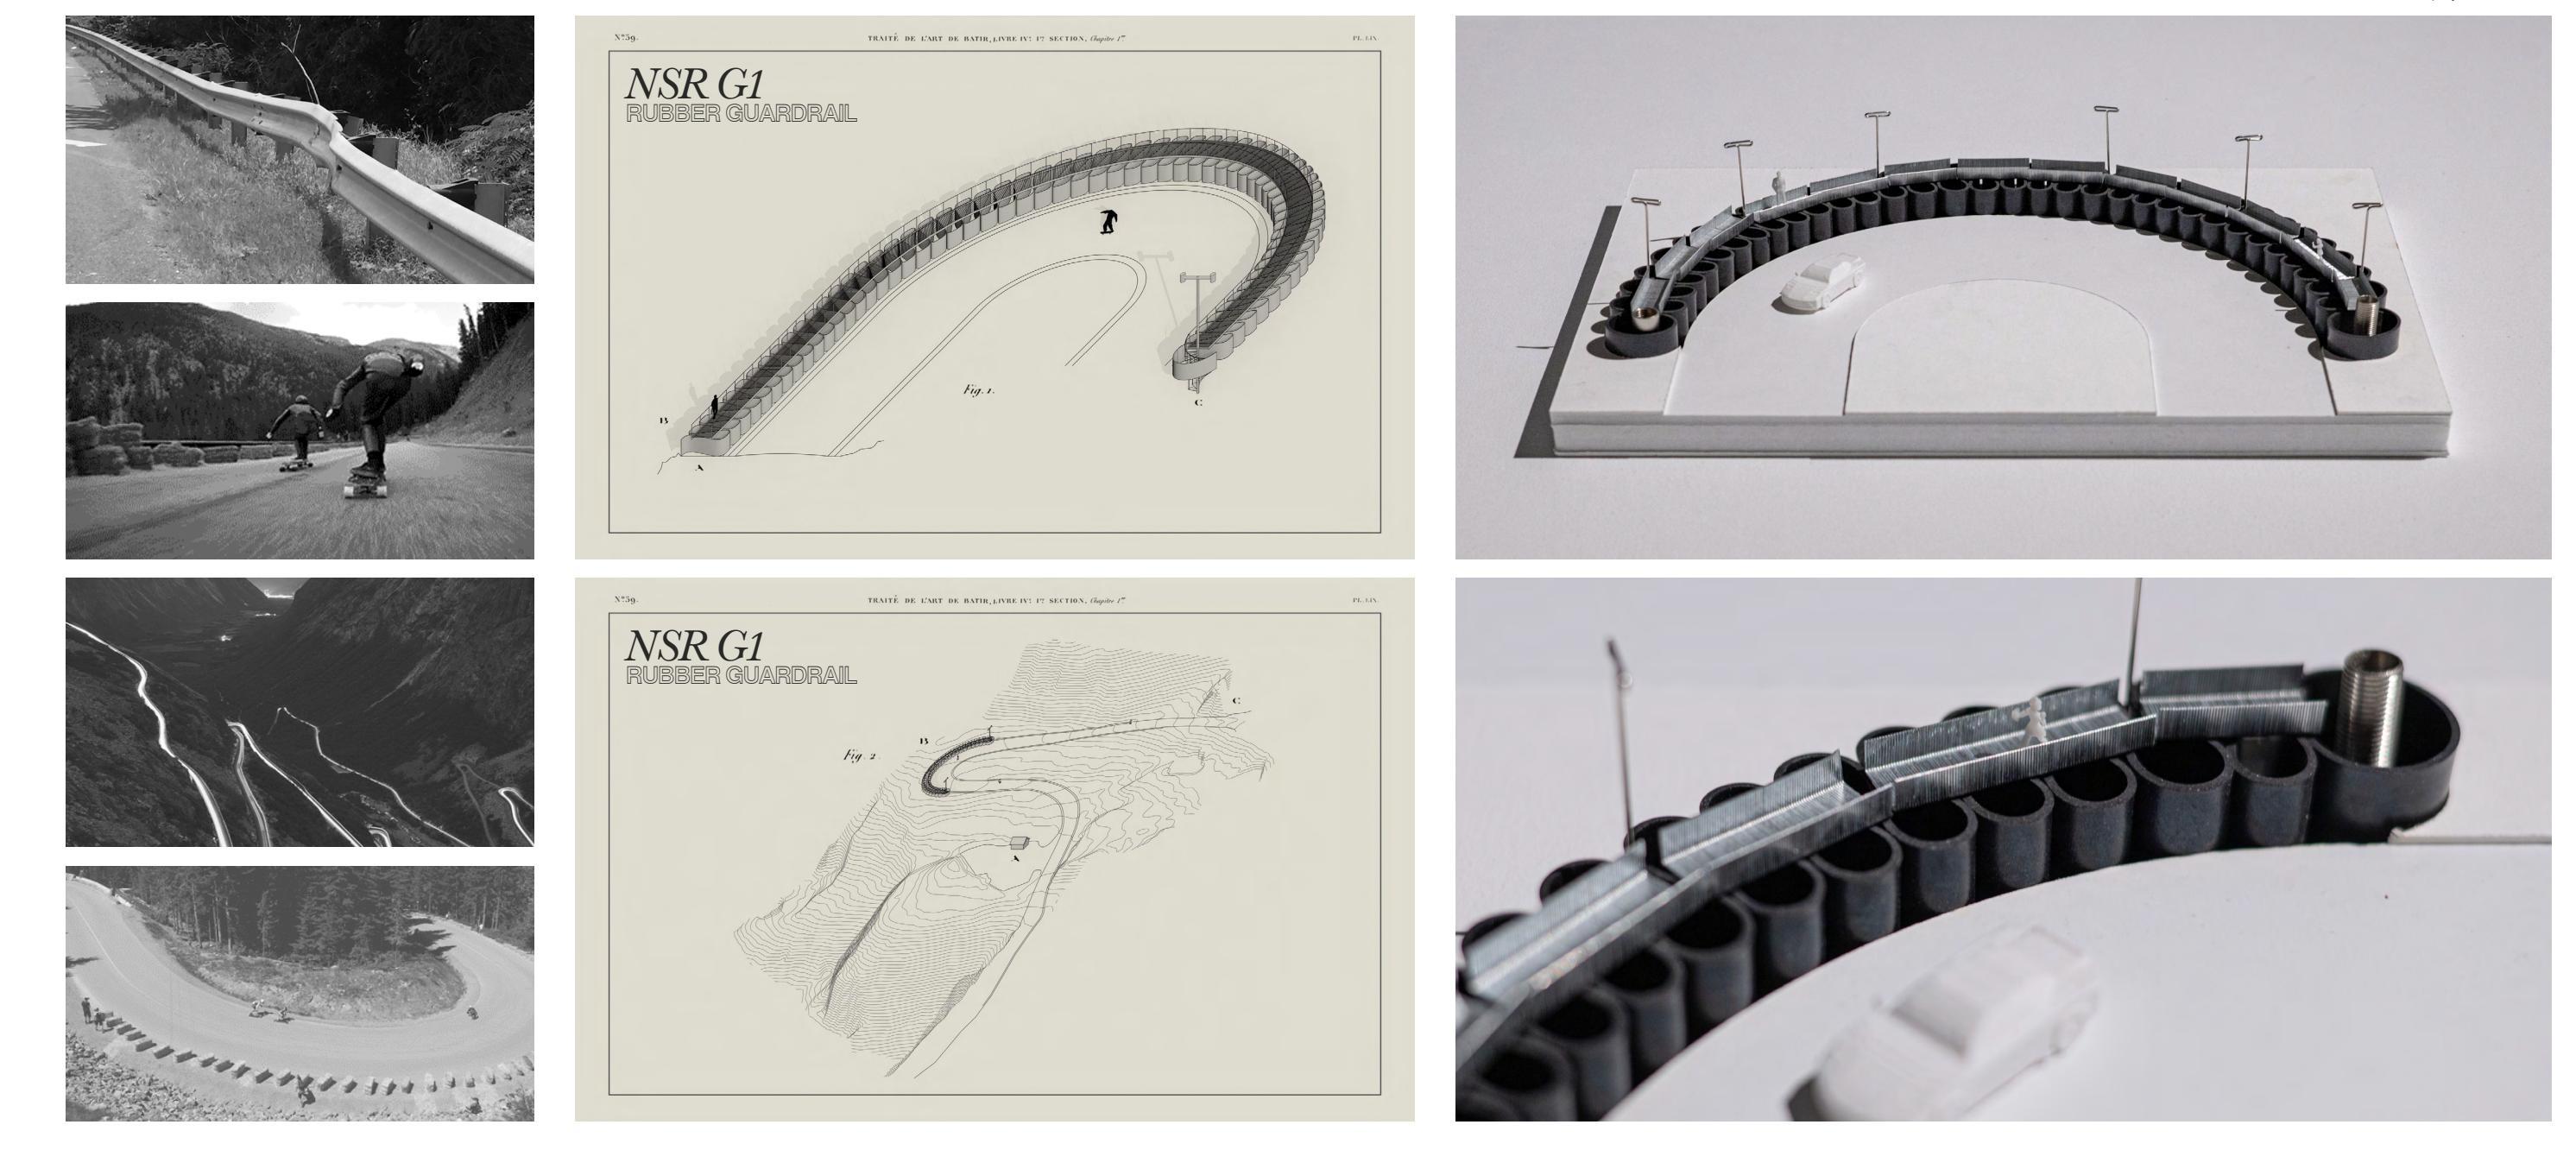
1" = 8' physical model

PROTOTYPE 1: Rubber Highway Guardrail Field Station

Rubber was identified as a material that could withstand impact from cars and downhill skateboarders alike. A corrugated module is elastic laterally, but stiff vertically. Typically, steel guardrails and hay bales (for skateboard races) are located at steep, downhill sections of highways with apex turns. These areas are often sites with beautiful views. This prototype makes use of the corrugated module and hosts a walkway on top of it.

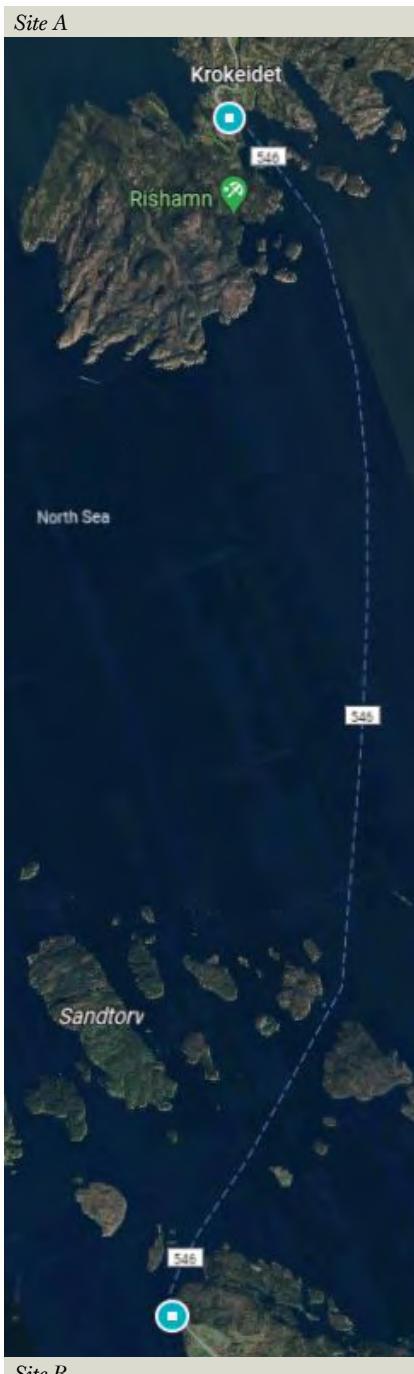
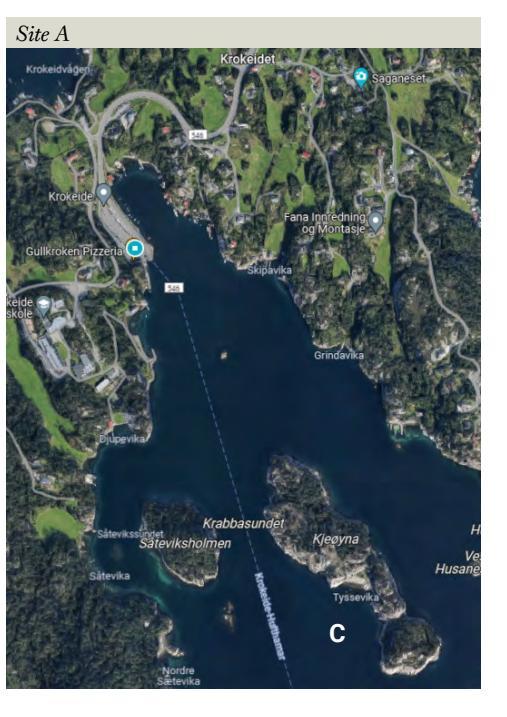
Typical Conditions at Ferry Terminals: Steep Roads leading to Rock & Asphalt at Sea level

Most ferry terminals have large rock formations that have been blasted or cut, with steep roads leading to them (perfect for downhill skateboarders). They are also infrastructural spaces that are underwhelming and full of asphalt and rubber. This project takes site A as the prototypical site condition.

legend (maps above): A. Rubber Base Station Boatshed B. Rubber Guardrail

C. Rubber Floating Dock

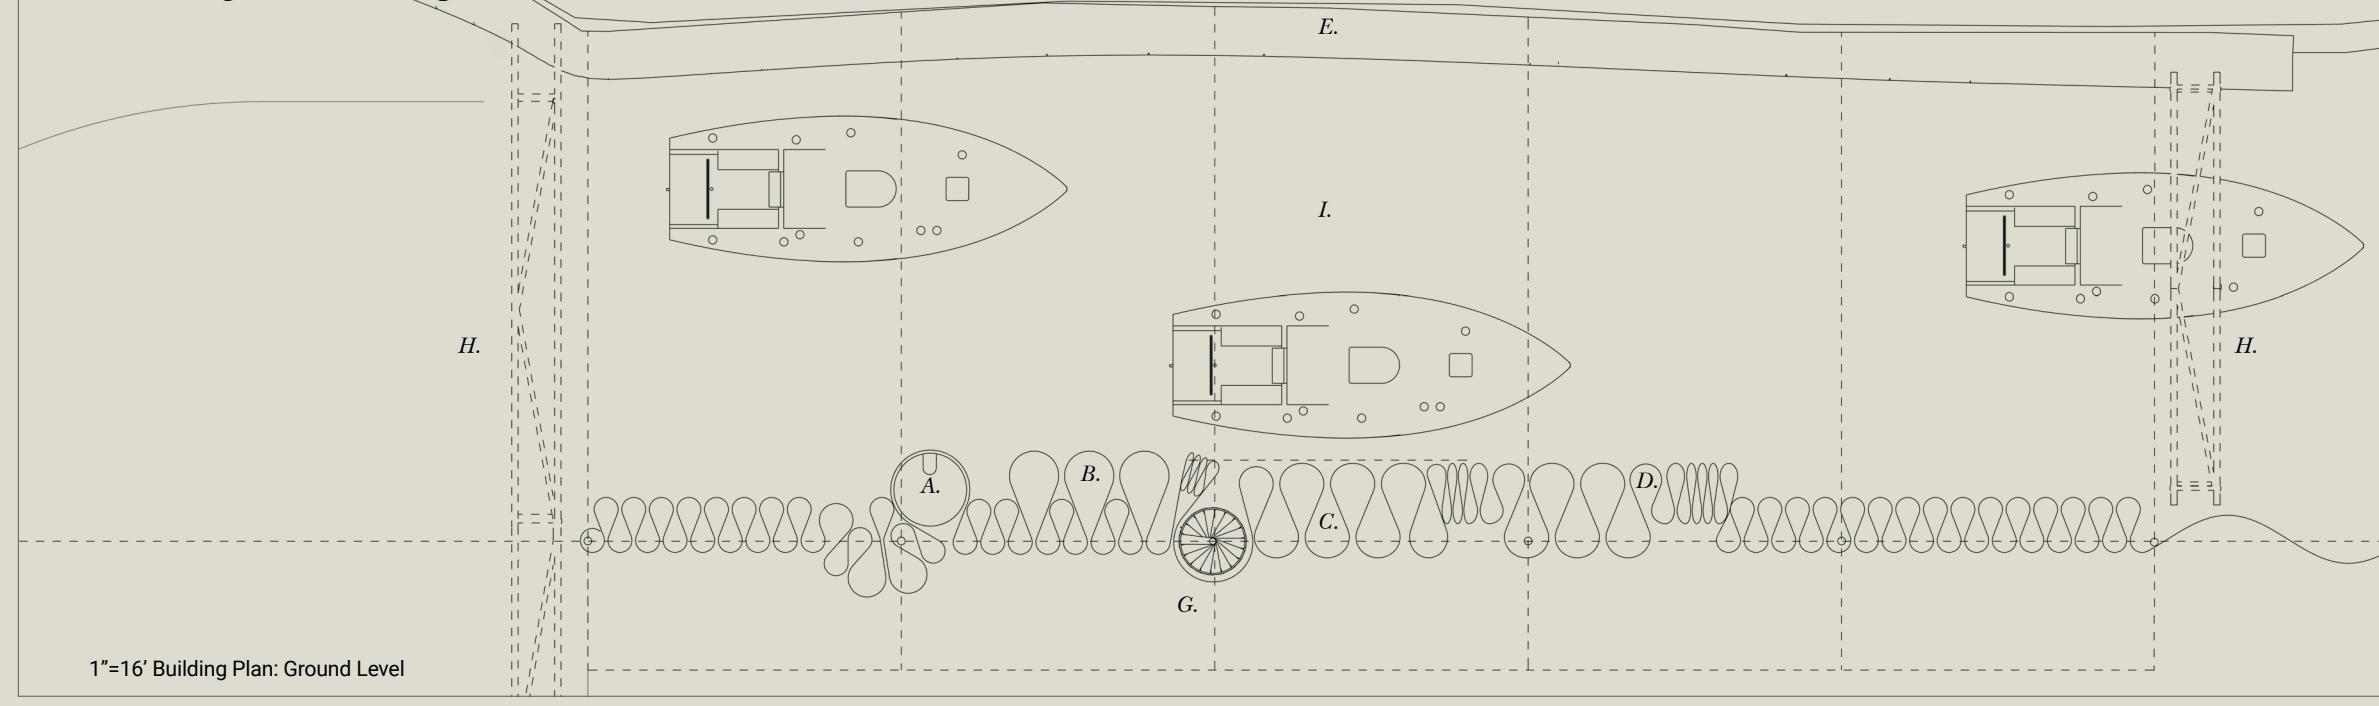
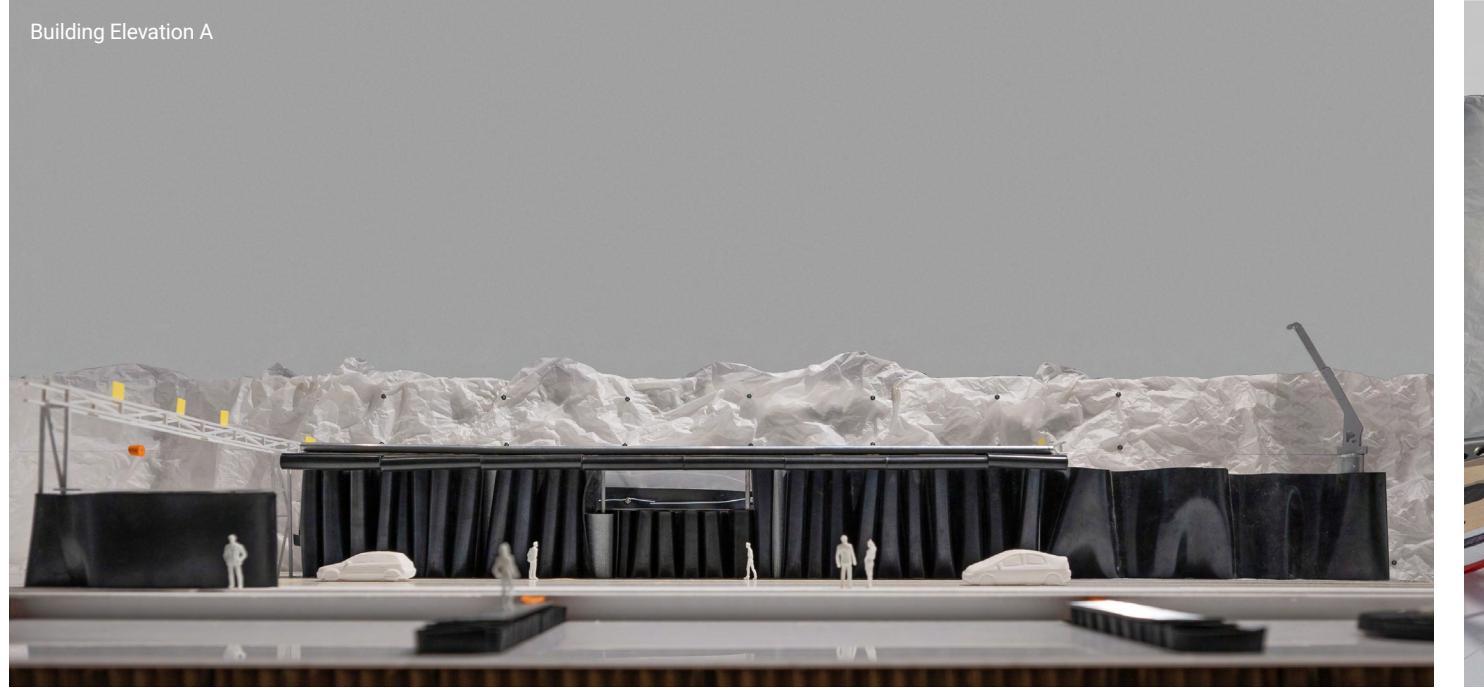
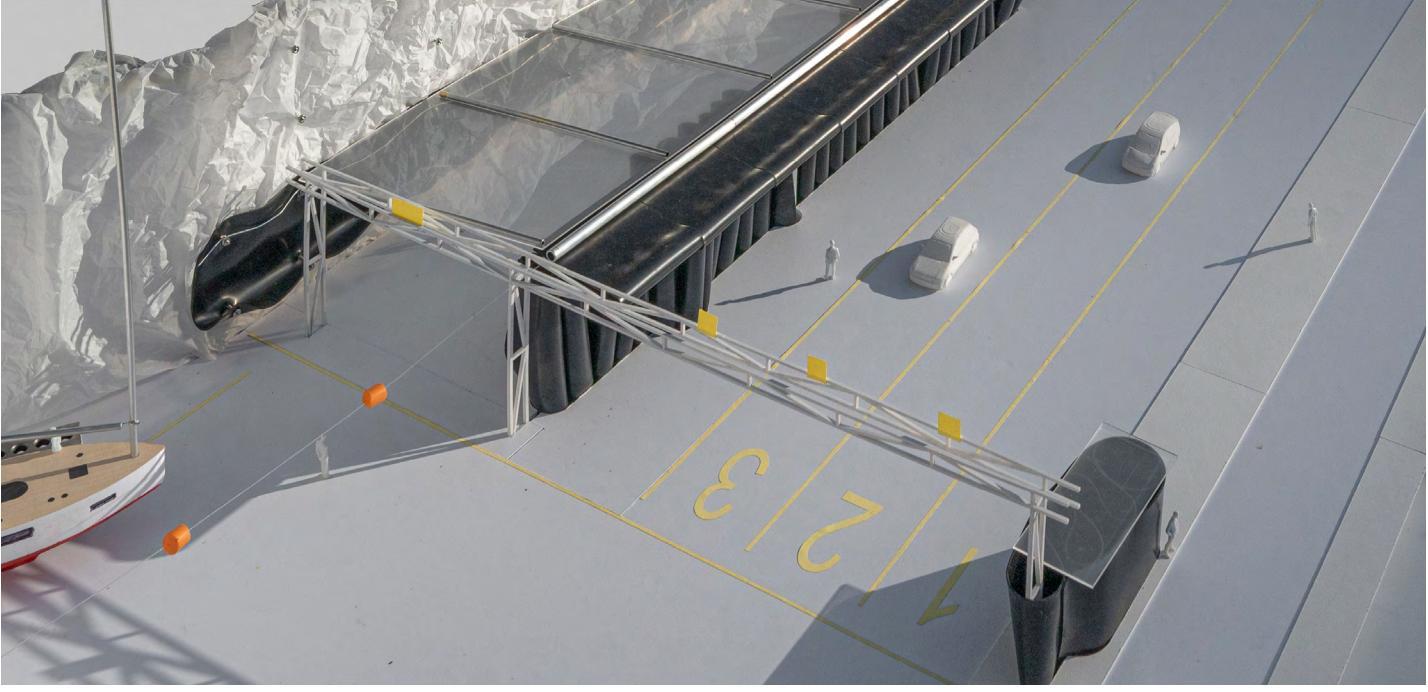
PROTOTYPE 2: Rubber Boatshed & Workshop

А.	Insulated WC
В.	Uninsulated WC
С.	Tool Storage
D.	Vending Machine for Travelers
Е.	Rubber Gutter
<i>F</i> .	Crane
<i>G</i> .	Spiral Stair to Mezzanine
Н.	Garage Door / Gate
Ι.	Flex Space
	(Exchange, Social Functions)
	· · · · · · · · · · · · · · · · · · ·
	T +
	E.
	L. L.
	\mathbf{E} ///

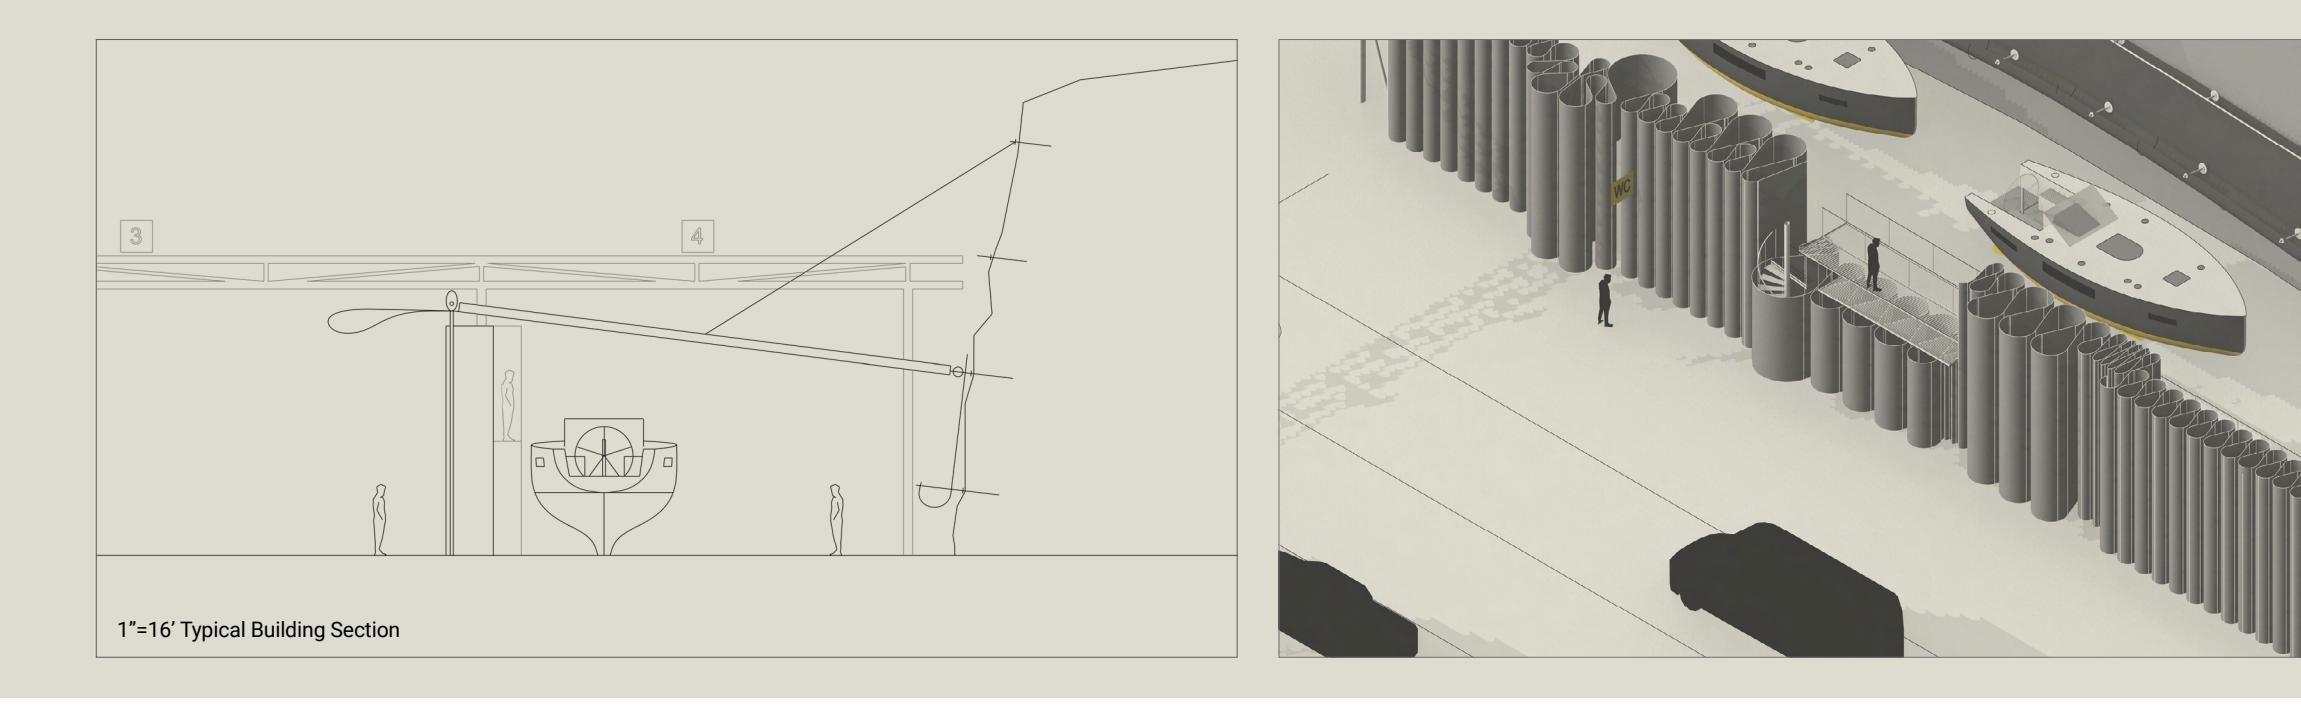
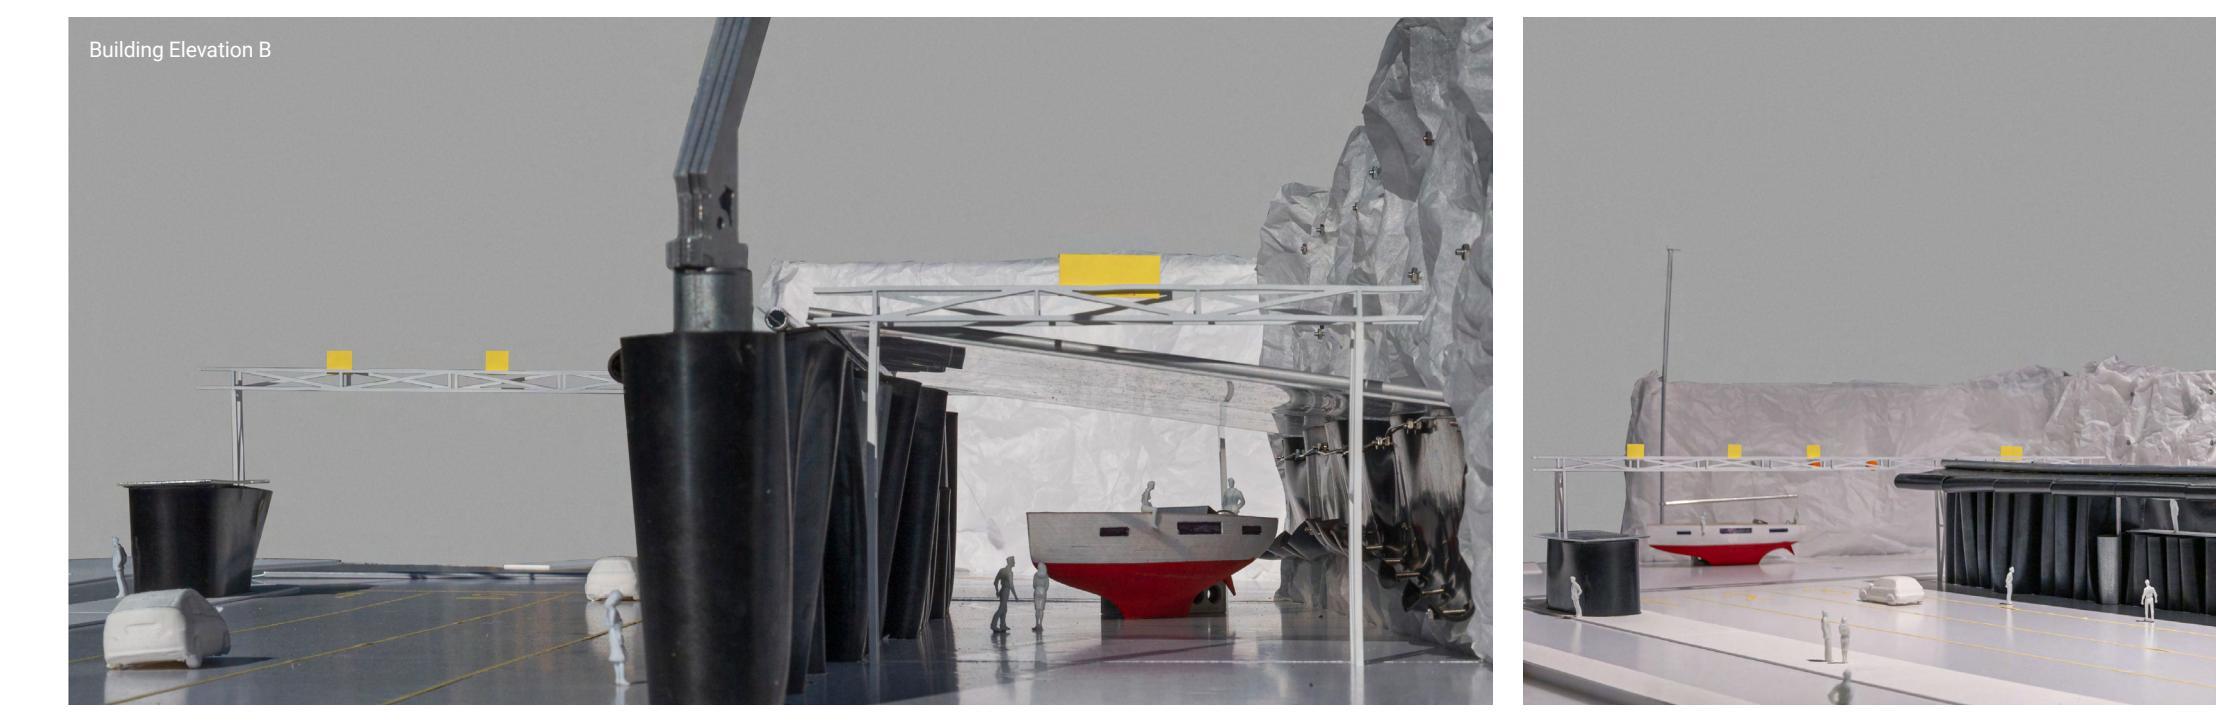
PROTOTYPE 2: Rubber Boatshed & Workshop

The structure relies on the corrugated rubber on one side, and the rock face on the other: The roof is a giant sail that is pulled taught in both directions by tensile elements.

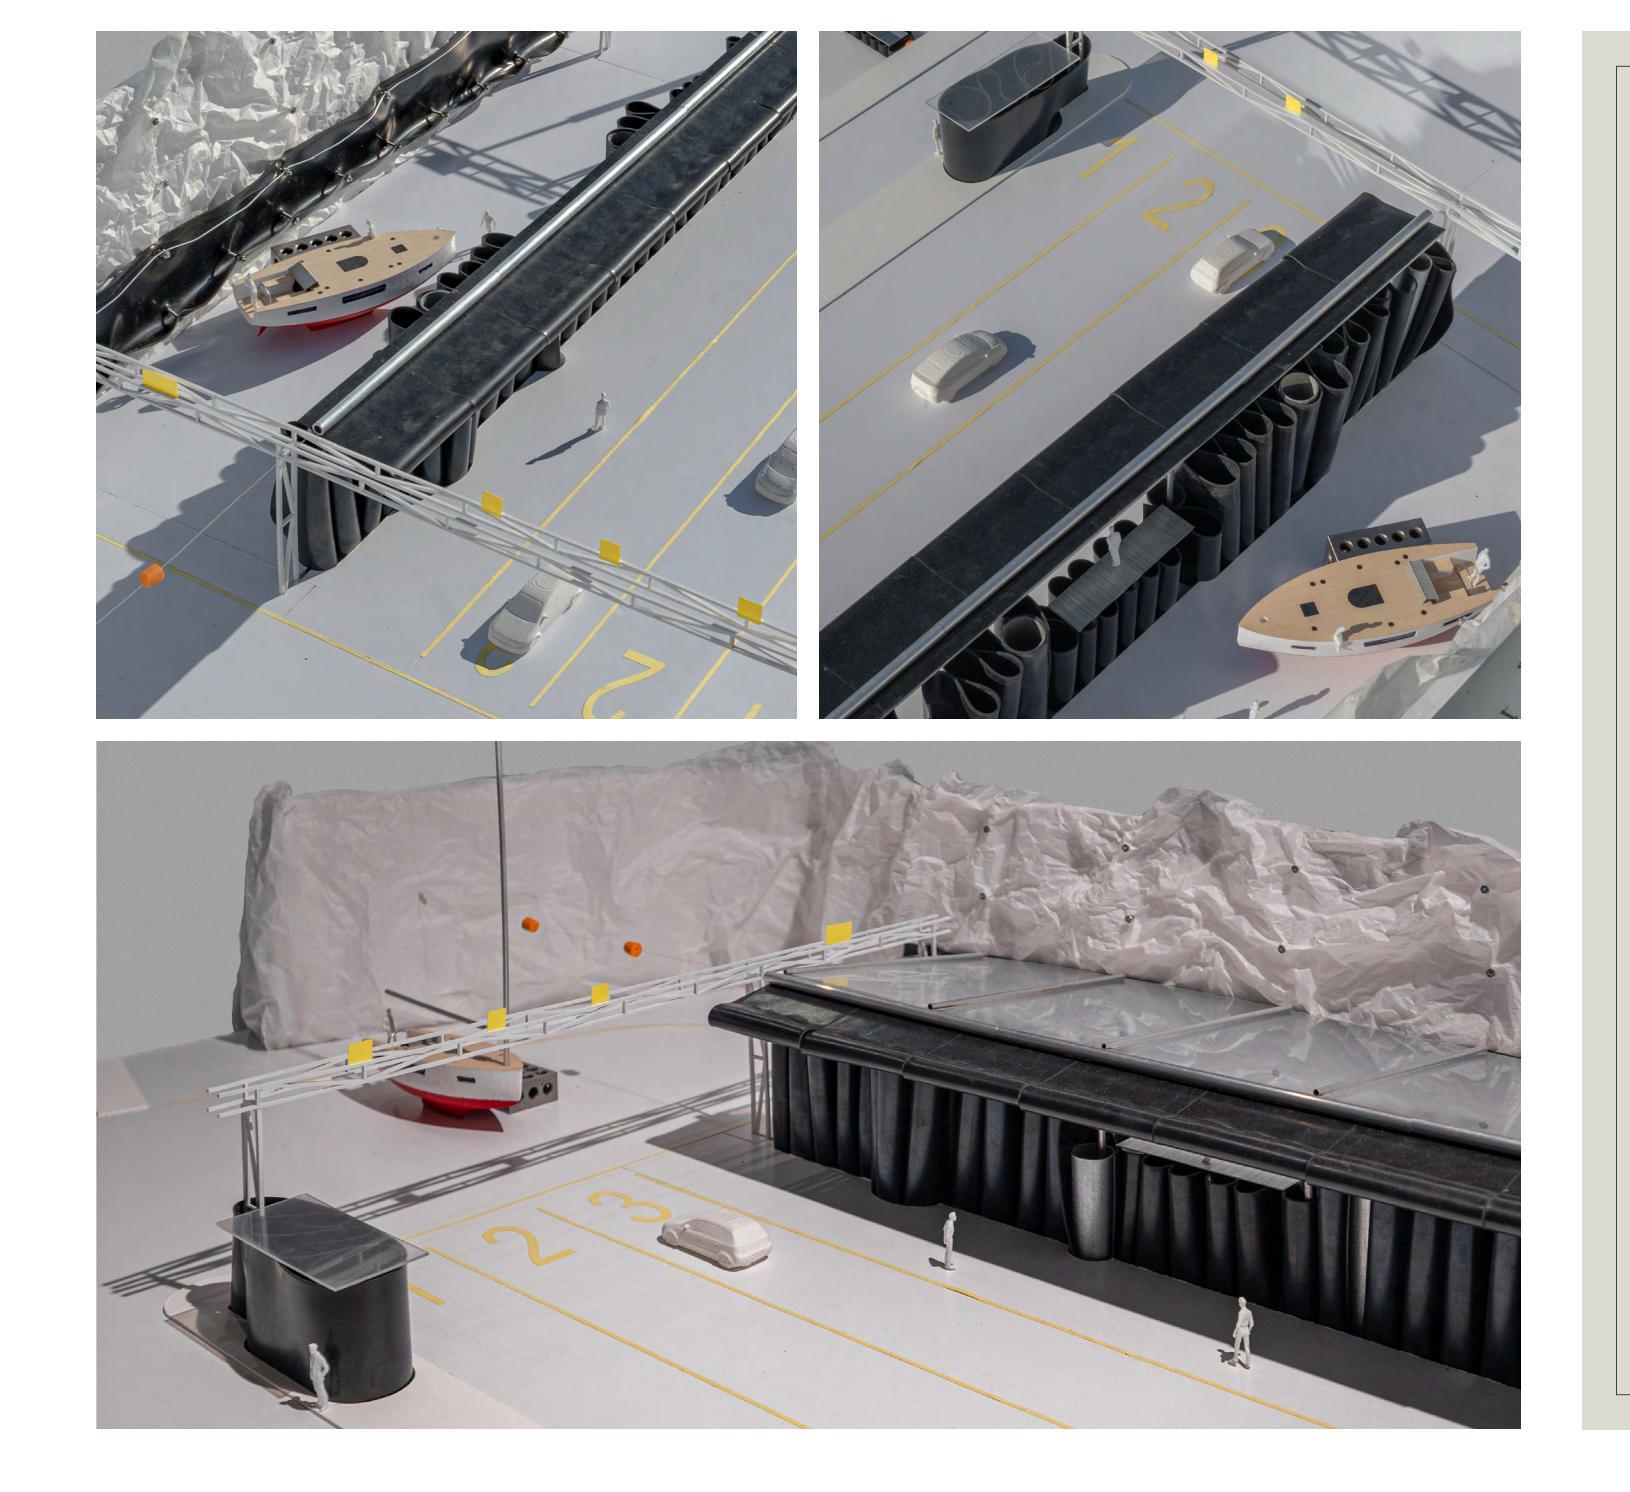
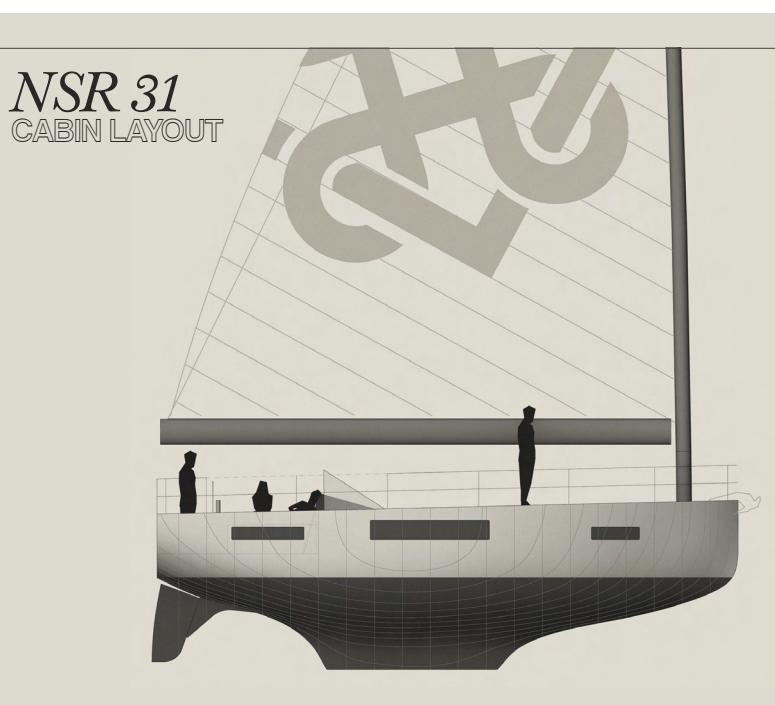
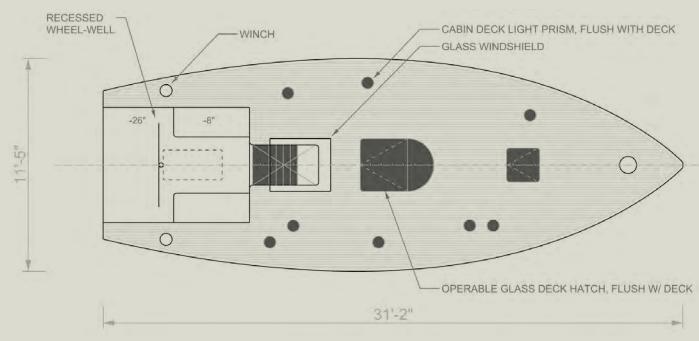
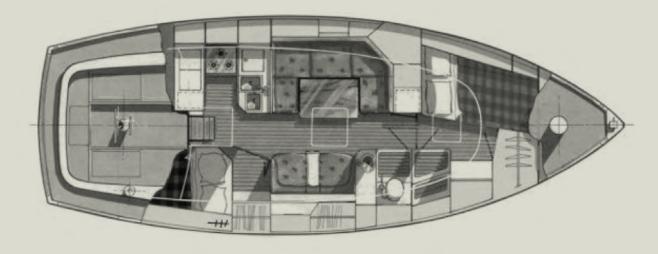
PROTOTYPE 3: Rubber Cruising Sailboat

A cruising sailboat for the workforce to visit different field stations from.

Most sailboats have cabin tops; this original design frees the deck of such clutter, and it becomes a flat surface for new activities. A single mast, located all the way forward, assists in this, and a tent can be strung over the boom.

31' was the smallest design that would achieve modest accommodations for 2 people with standing room in the cabin (6'-3" clear).

The interior layout is based on the nonsuch 30' catboat design, which also employed a freestanding carbon fiber mast.

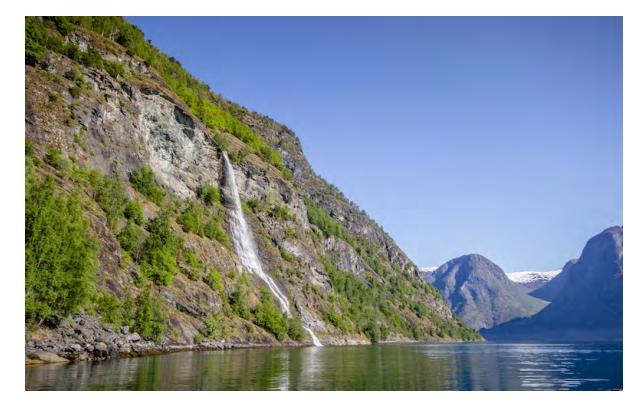
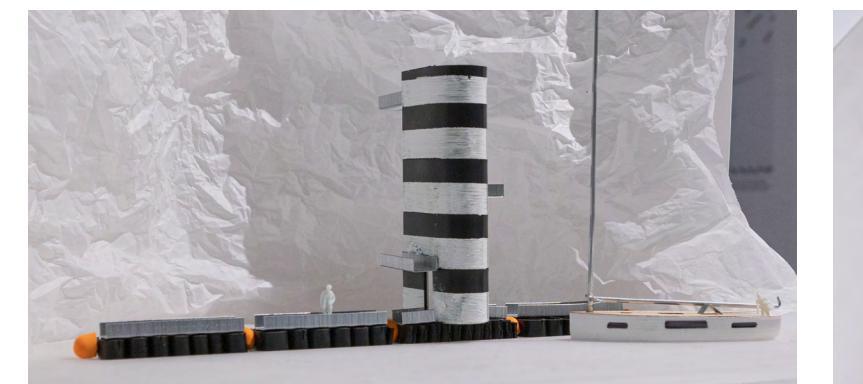
PROTOTYPE 4: Floating Rubber Field Station

A floating field station to study the affects of highway runoff and sewage on marine ecosystems and water quality. Once remediated, the same structure is added to above to become a diving tower, a typical recreational activity in Norwegian culture.
